Detection of Voids in Prestressed Concrete Bridges using Thermal Imaging and Ground-Penetrating Radar

WA-RD 717.1

December 2008

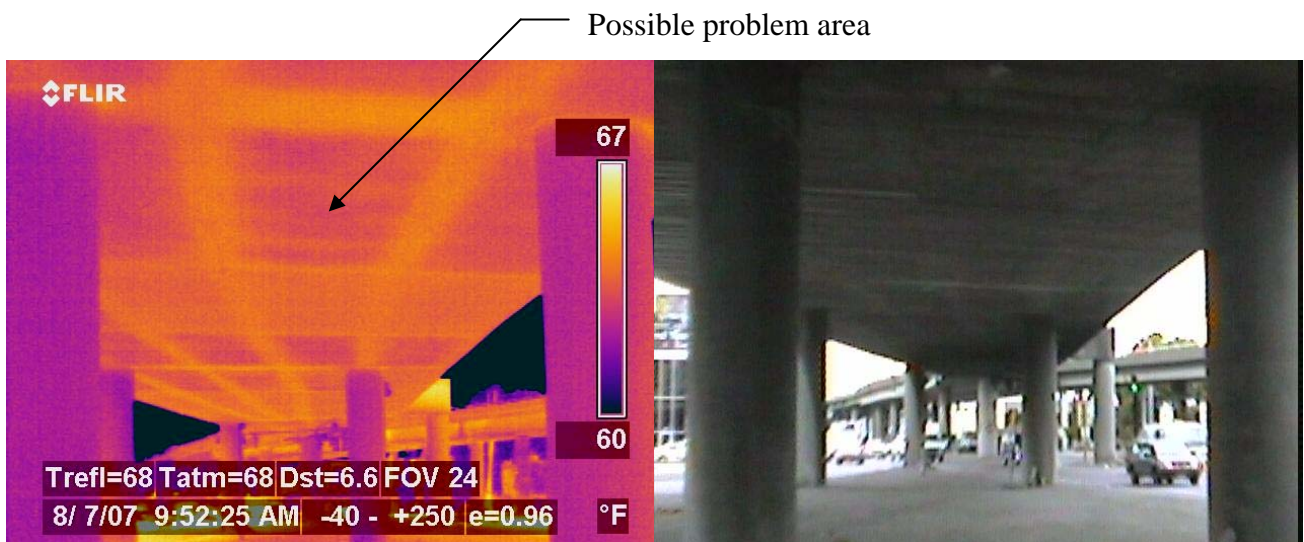
Figure 18 – Thermal image and photo of box girder bridge under ambient conditions

The thermal imaging camera was often used to locate possible heating locations based on ambient conditions. Images were taken and hot or cold regions in the image were identified as potential problem areas. Figure 18 shows a thermal image of the bridge under typical ambient

conditions from which a heating location might be determined. The arrow points to a location which should be a solid color inside a rectangle of yellow indicating a uniform temperature distribution. The yellow areas in the image signify locations of interior webs of the box girder. However, a closer look at the image reveals a few areas with higher surface temperatures than the surrounding concrete within the rectangle. This signal of inconsistency may indicate a problem area.

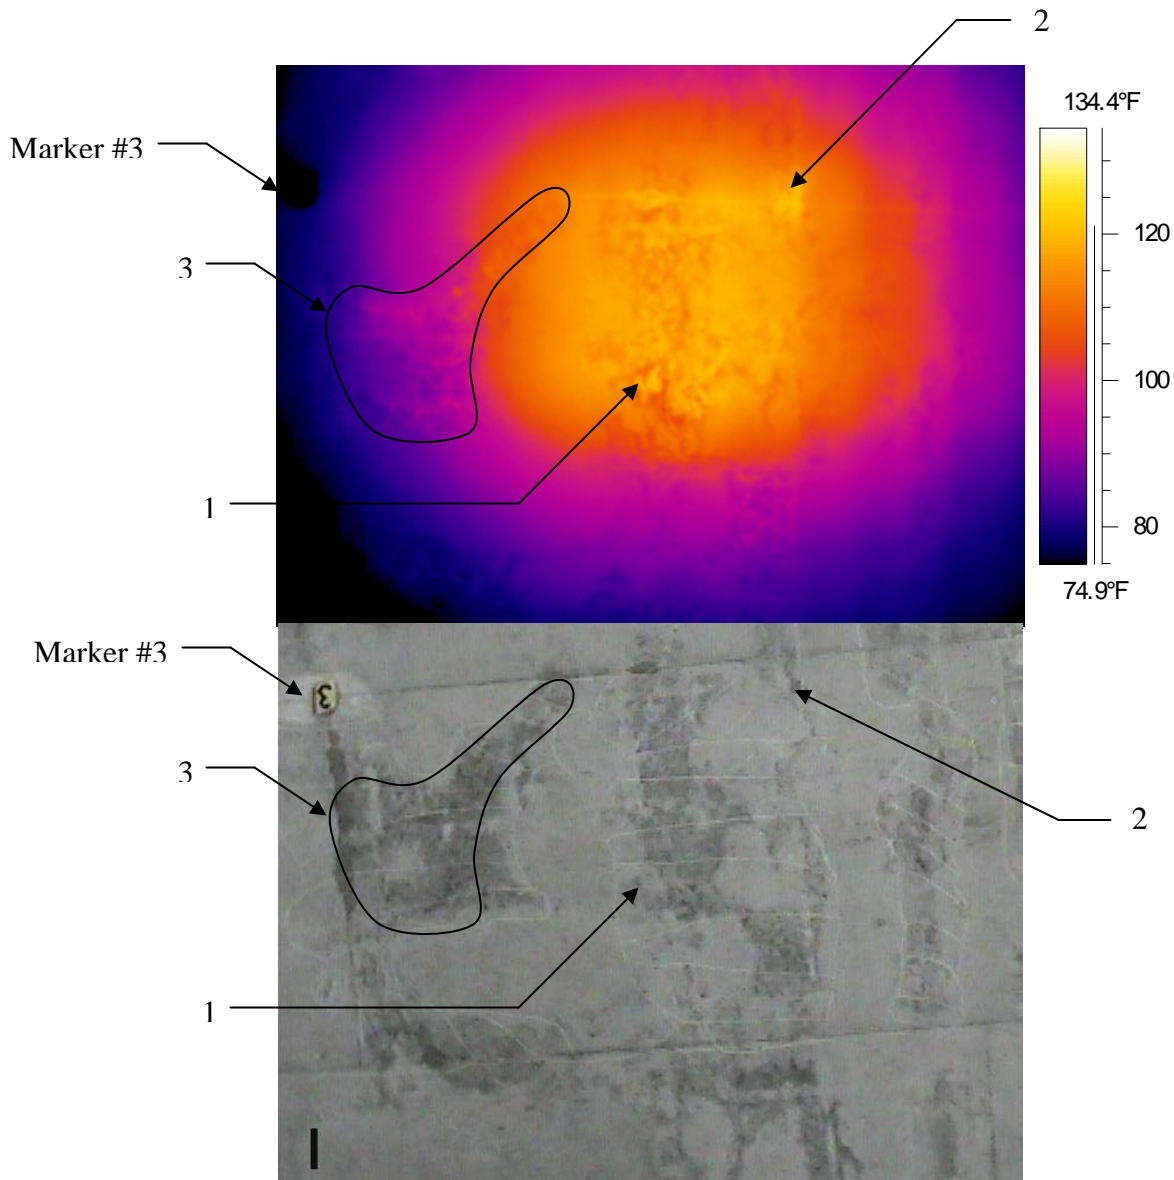
Figure 20 – Thermal image and photo of Heating Location # 1

Heating Location # 1 was inspected on August 6th, 2007 using inspection Method 2. The inspection position was in Span 11 between marker # 1 and marker # 3 (markers were attached to the surface during prior WSDOT inspections). The surface was heated for a time span of 1:45 (hh:mm). The top of the heater was placed approximately 76 cm (30 in.) from the heated surface, which was 7.1 m (23.2 ft.) from the ground. This location was chosen because it was an area that had already been inspected by WSDOT, as indicated by the white chalk in Figure 20. The objective was to see how the thermal images displayed what was previously discovered. Figure 20 shows a thermal image and a corresponding photo of the heated surface. The figure also shows three regions of interest on the heated surface. These regions are clearly shown in both the photo and the thermal image as locations with thermal anomalies.

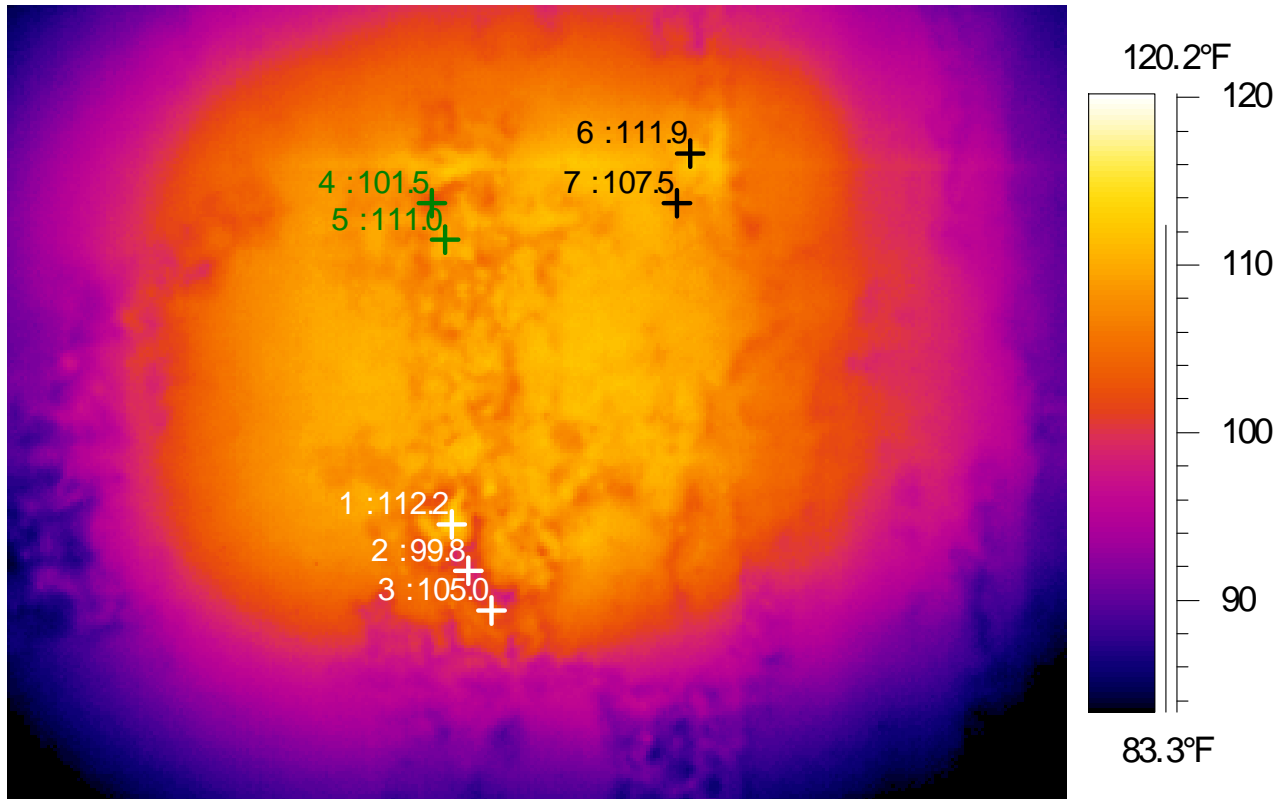
Figure 21 – Thermal image of Heating Location # 1

away from the heated center. This shows that there was an irregularity at this location, which was at approximately the same location as region 1 in Figure 20.

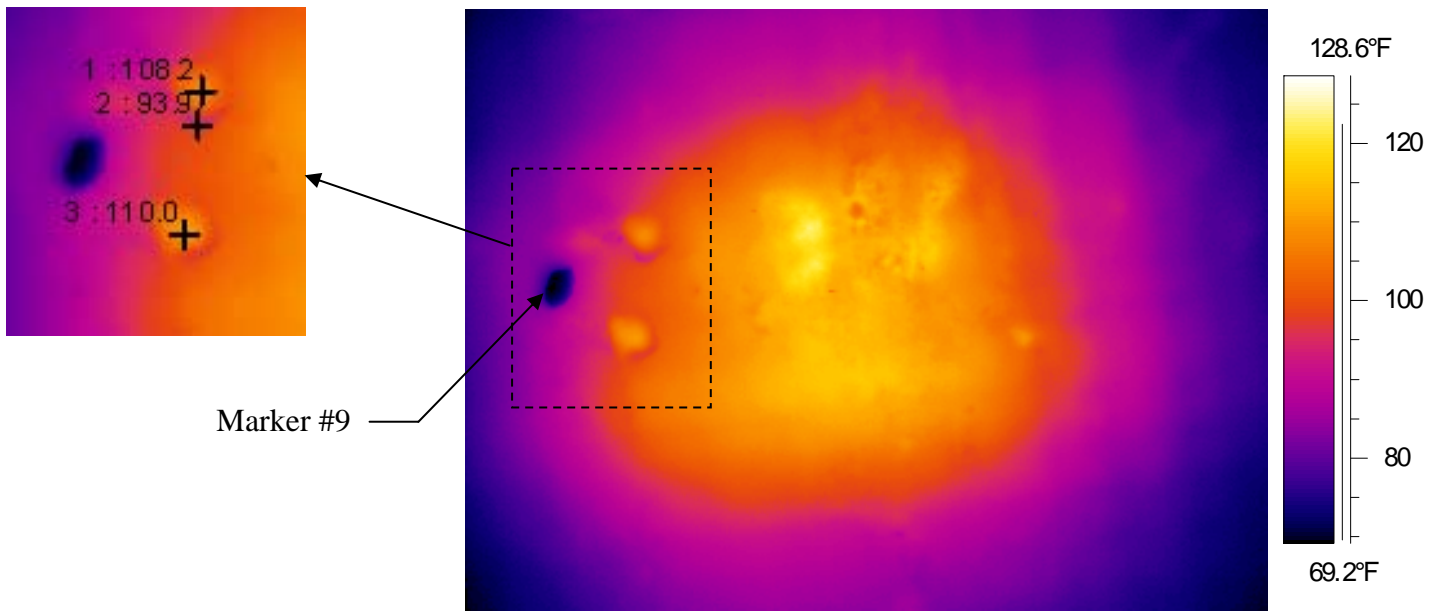
Figure 22 – Thermal image and enlarged area showing spot temperatures of Heating Location # 2

Figure 22 shows a thermal image of Heating Location # 2. The black mark on the left side of the image is marker # 9, and marker # 7 would be on the right side if it were within the viewing range. This image is a very good example of delamination, as indicated by the two “spots” located to the right of the marker # 9. These two areas look like hot spots because of the delamination (separated layers within the concrete) that keeps the heat from propagating farther into the floor of the box girder. The heat propagates at a slower rate due to a layer of air present at the delamination interface. The air acts as an insulator, keeping more heat within the layer of concrete nearest the heat source. The delaminations in the thermal image were confirmed by WSDOT inspectors through tapping the surface with a hammer after the thermal imaging was completed. Figure 22 also shows three points that demonstrate the temperature differences in the vicinity of hot spots. The temperature difference between points 1 and 2 is approximately 14 °F and can be attributed to the delamination occurring between the two points.

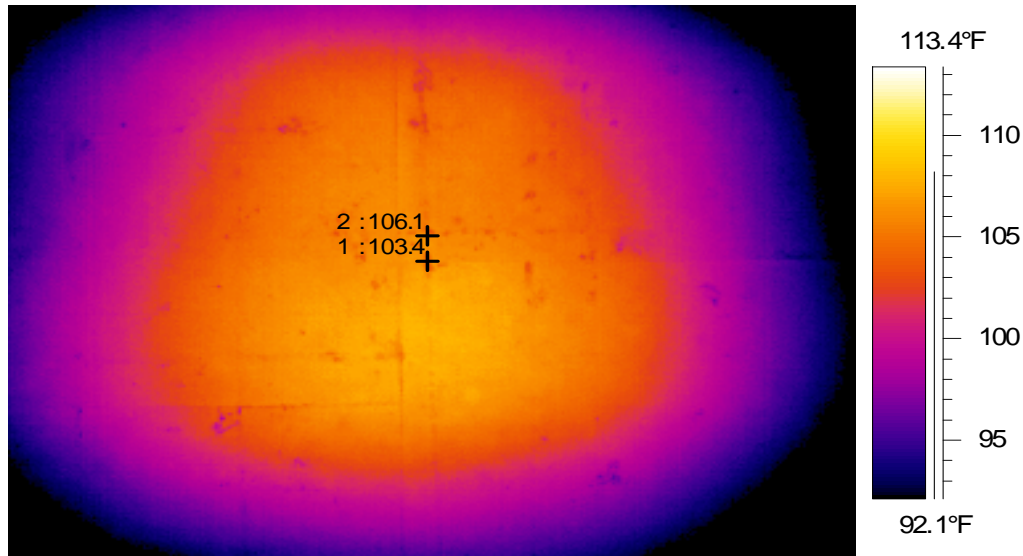
Figure 24 – Thermal image of Heating Location # 4

Figure 24 shows a thermal image of Heating Location # 4. Many small irregularities were detected in this image. An example is at points 1 and 2 in the middle of the image. Point 1 is closer to the heated center than point 2, but it is almost 3 °F cooler. Based on more analysis of the image with the thermal imaging software, most of the other irregularities were found to be approximately 2 to 3 °F cooler as well. Since the irregularities are not substantially different in

terms of temperature, one can conclude that they are just surface marks or areas where a small amount of concrete has spalled off.

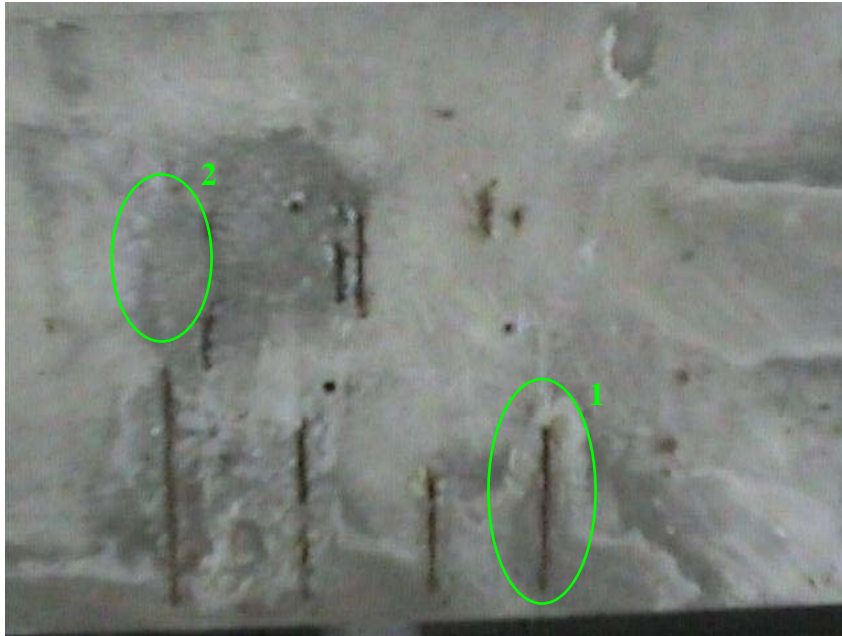
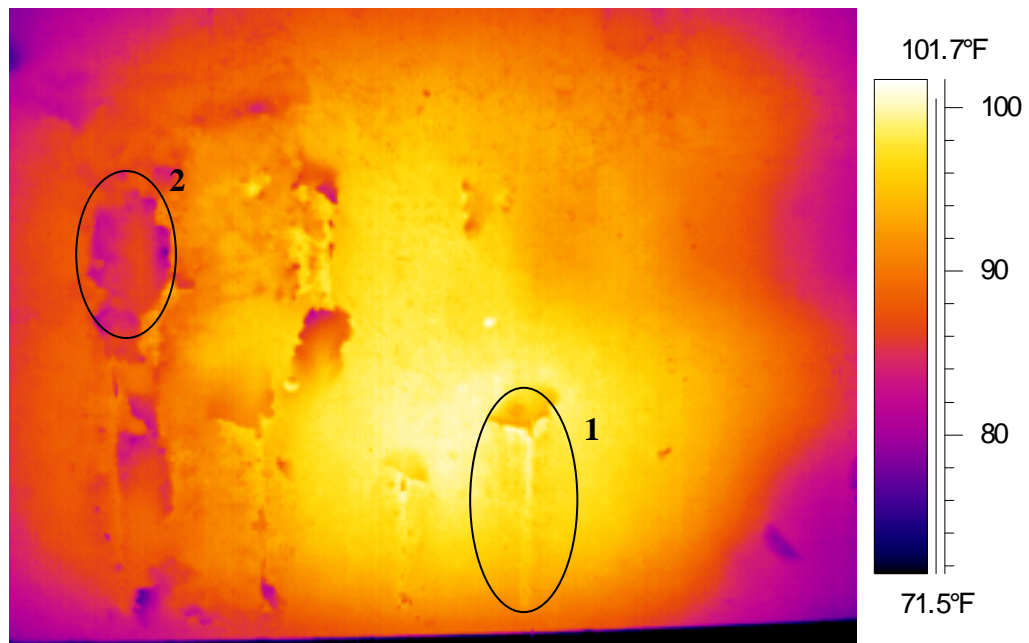
Figure 26 –Thermal image and photo of Heating Location # 5

Figure 26 shows both a photo and thermal image of Heating Location # 5. This figure is helpful because one can see exactly how each area in the photo appears in the thermal image. An example is the steel reinforcement. It is seen exposed in the photo, and then as a warmer line in the image, designated by circled area 1 in the figure. Most of the longitudinal rebar can be traced in a similar manner.

Circled area 2 in Figure 26 shows an interesting irregularity. The area doesn't display anything significant in the photo except a small amount of discoloration, but the thermal image demonstrates inconsistencies in the material in the form of great temperature differences. The thermal imaging software showed an approximate 5 °F difference between areas within the circle. This may be due to delamination, poorly consolidated concrete, or another irregularity, but there is no way to be certain of the specific cause until further tests are completed (either "sounding" with a hammer, or chipping out the loose concrete). This does, however, reveal that there may be a problem at this location. There are also a few other areas in the figure that exhibit similar temperature anomalies.

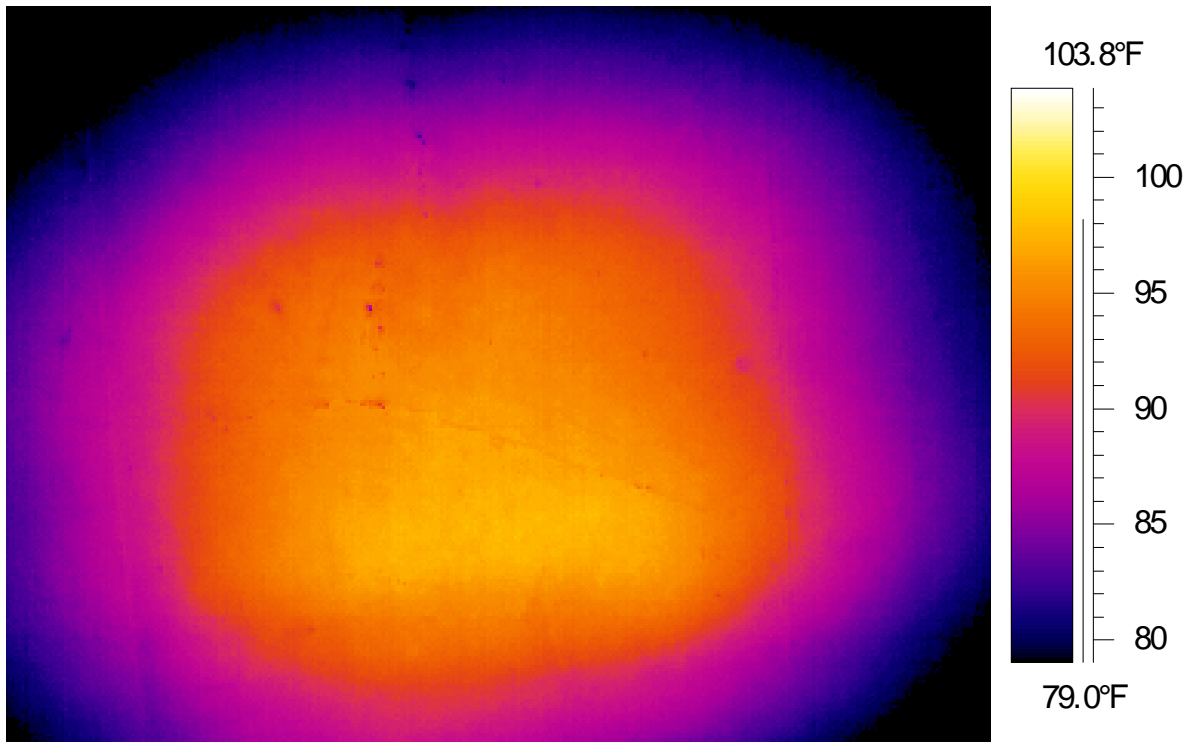
Figure 27 – Thermal image of Heating Location # 6

Figure 27 shows a thermal image of Heating Location # 6. This inspection did not detect any irregularities. The concrete surface seems to have no flaws. However, the inspection does show some of the surface texture characteristics. In the center of the thermal image, for example, is an area where concrete protrudes a very short distance beyond the flat surface. The surface feature looks like a line with a downward slope. The thermal image also demonstrates how very small surface defects can be detected.

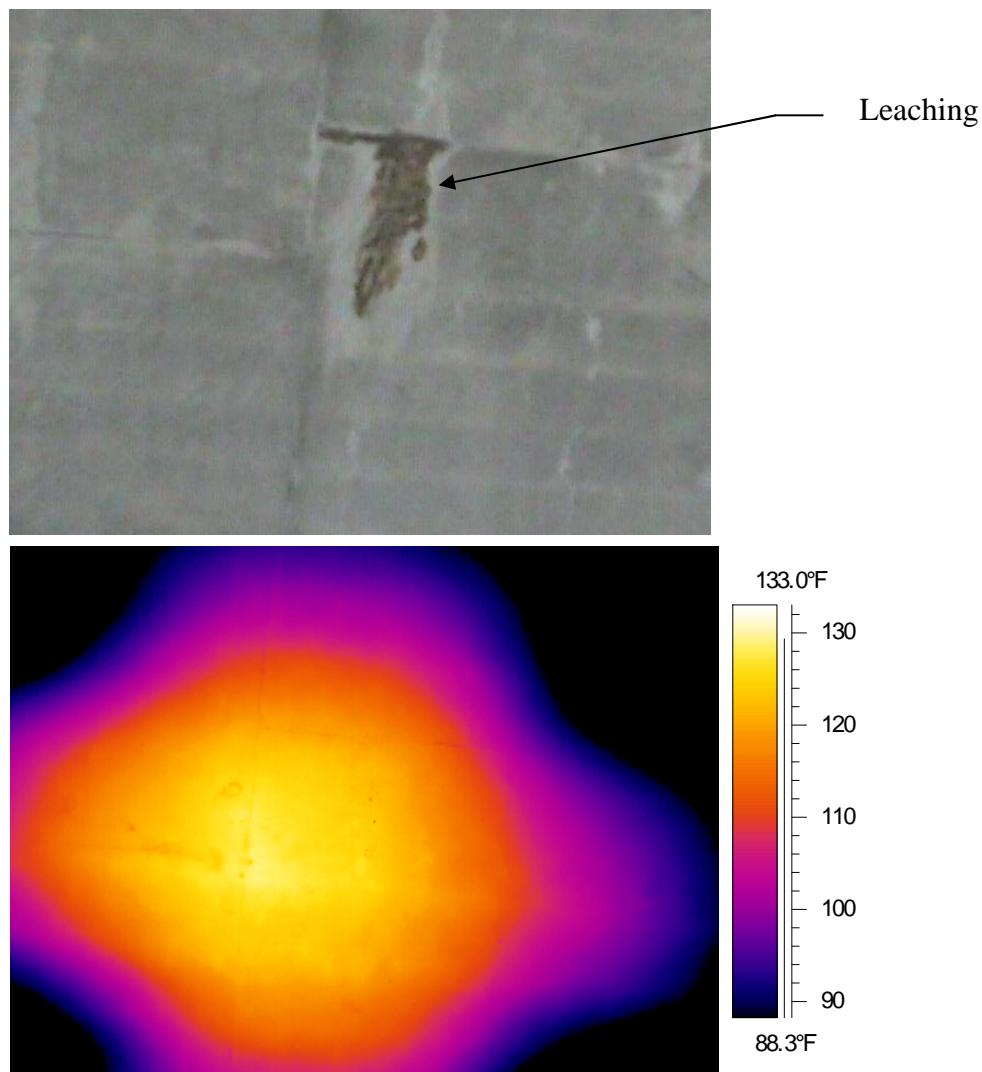
Figure 28 – Thermal image and photo of Heating Location # 7

Figure 28 shows a thermal image and photo of the unheated surface from Heating Location # 7. This area was chosen because of discoloration due to leaching on the bottom surface of the box girder. The leaching may have been caused by water pooling inside the box girder at this location, and then leaching through. However, the thermal image in Figure 28 does not show any irregularities. This indicates that there are no delaminations or air voids near the surface of the concrete.

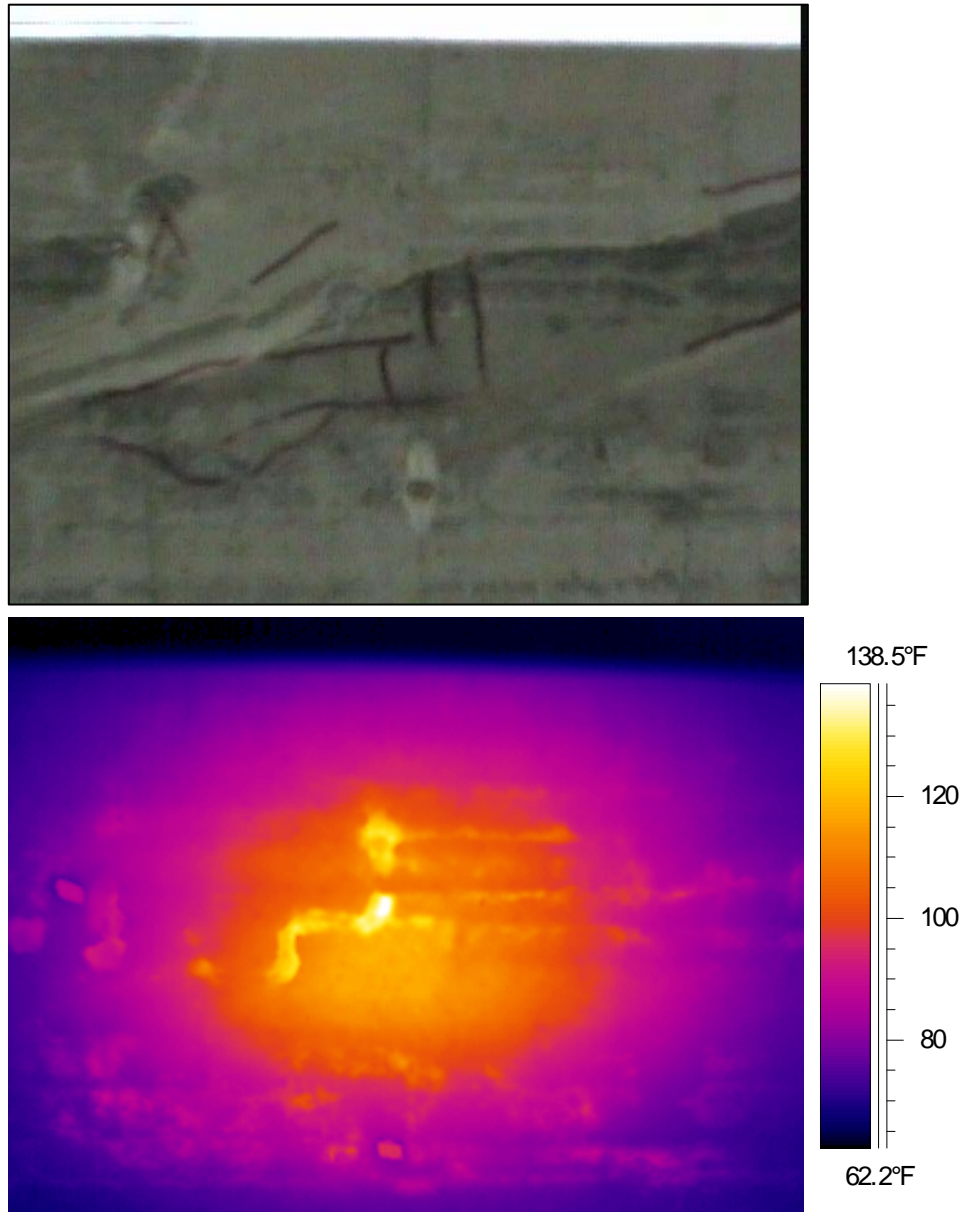
Figure 29 – Thermal image and photo of Heating Location # 8

Figure 29 shows a photo and thermal image of Heating Location # 8. From the photo, one can see that the surface had been marked during previous WSDOT inspection. The markings were somewhat unclear, or at least they did not match up with anything in the thermal image. The image, however, does show a great deal about the surface. In the middle of the heated surface area were a few flaws that varied greatly from the areas around them. Temperature differences ranged from approximately 12 °F to 24 °F between the irregularities and the surrounding concrete. The left side of the image revealed some flaws as well, but they were not very clear because heat was not directly applied to that area. The flaws on the left side of the thermal image do demonstrate, however, that a lot of direct heat is not necessary for flaws to be detected.

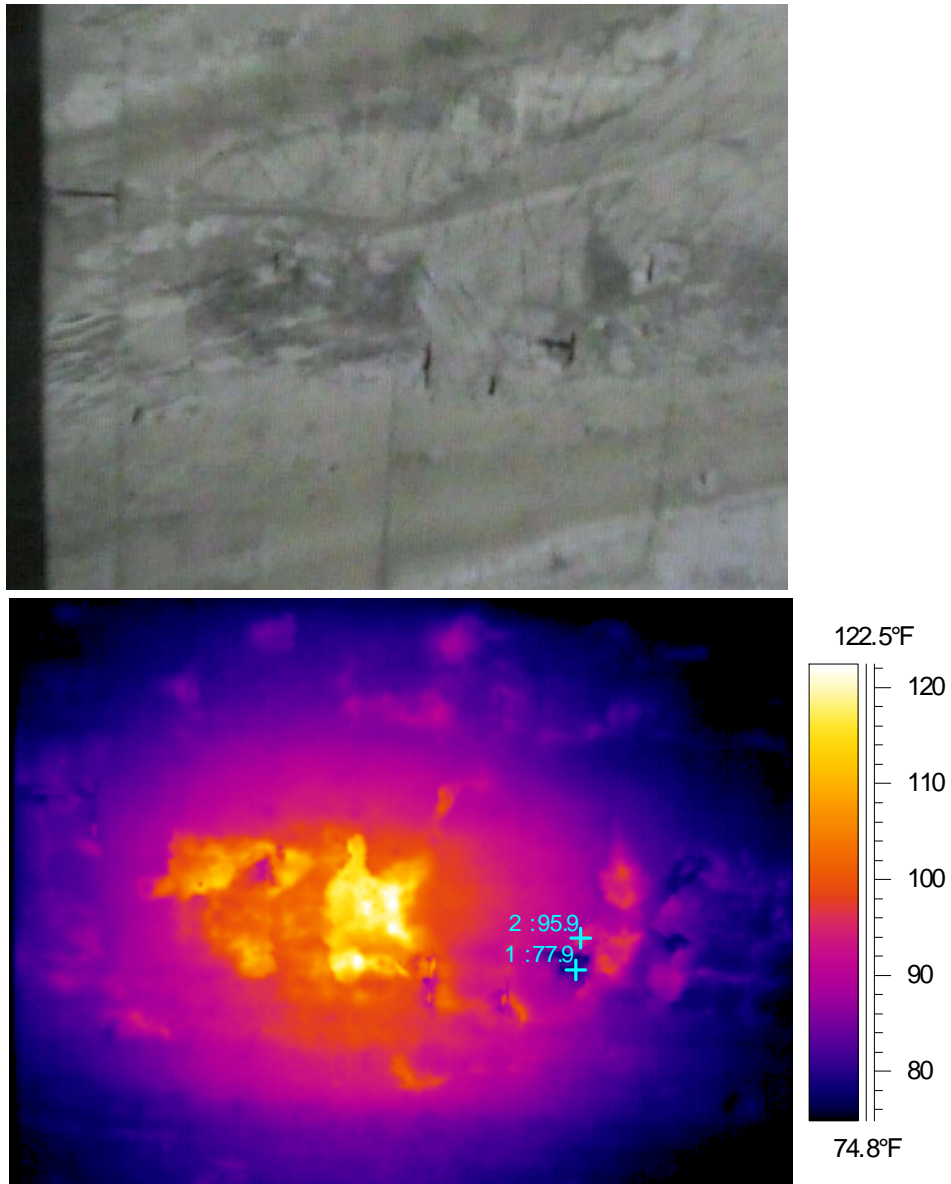
Figure 31 – Thermal image and photo of Heating Location # 10

Figure 31 shows a thermal image and photo of Heating Location # 10. This image exhibits a lot of temperature variation. An example exists with points 1 and 2 on the right side of the image. Point 1 is located on a cool spot at 77.9 °F, while just a few inches above, point 2 is warmer at 95.9 °F. This is a temperature difference of 18 °F. There are more variations like this throughout the image, thus irregularities are present. Also, around the edges of the heated area, small regions of elevated temperature are visible in the thermal image. They show inconsistencies in the concrete surface. When looking at both the thermal image and the photo, it appears that temperature variations occur where visual discoloration is present.

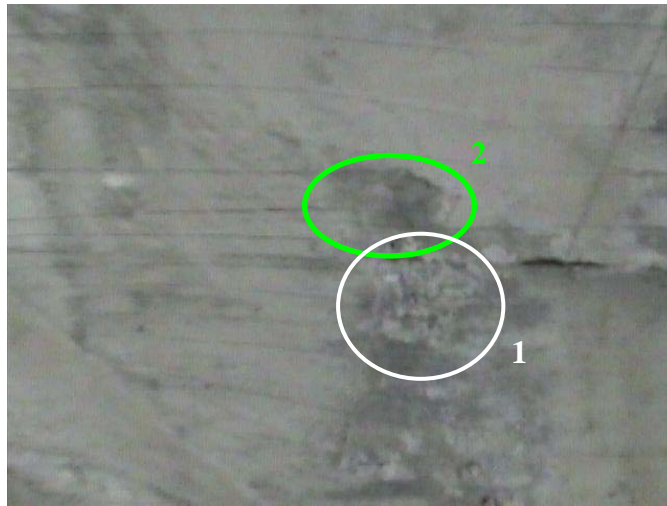
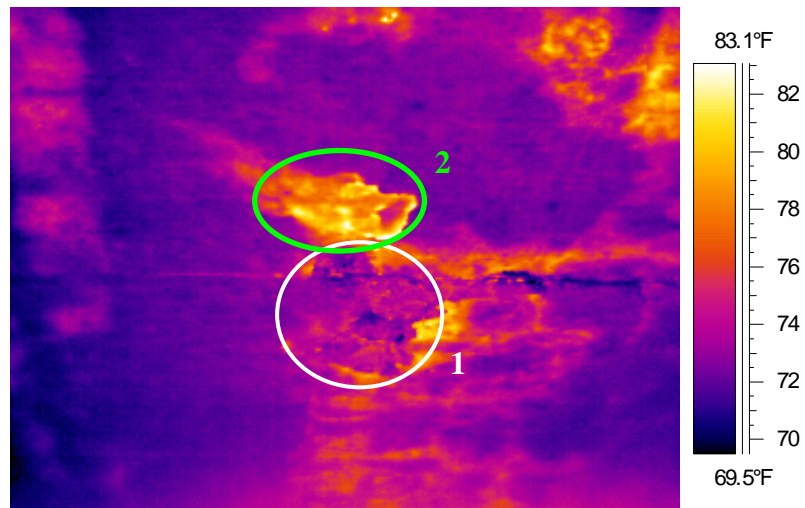
Figure 32 – Thermal image and photo of Heating Location # 11 approximately 10 minutes after heating began

Figure 32 shows a thermal image and photo of Heating Location # 11 that were taken approximately 10 minutes after heating began. Visible flaws were present on the heated surface and temperature differences between warm and cool areas were approximately 7 °F. The thermal image shows that not much heat time is needed to detect surface irregularities and obtain a significant temperature variation. Figure 32 also shows what looks like spalled concrete (denoted by circle 1) and an area of delamination (denoted by circle 2).

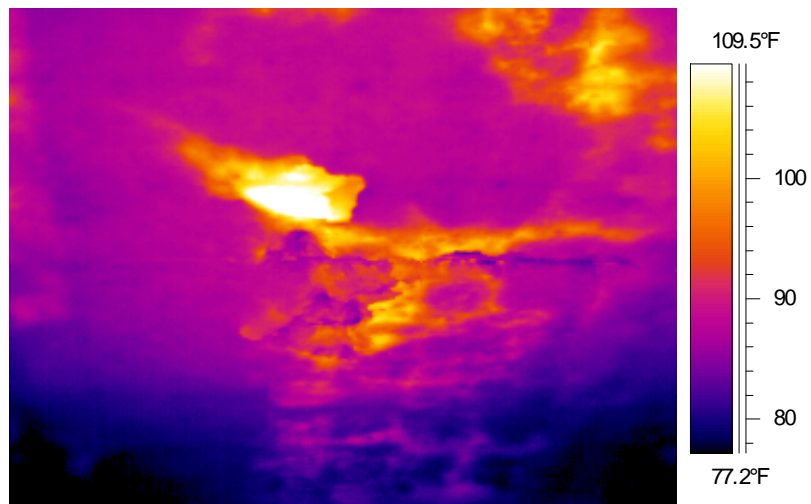
Figure 33 – Thermal image of Heating Location # 11 approximately 40 minutes after heating began

Figure 33 shows a thermal image of Heating Location # 11 taken approximately 40 minutes after heating commenced. When comparing Figures 32 and 33, it is evident that a lot of surface detail was lost as the heating time increased. This is likely due to the camera's automatic adjustment to a broader temperature range. Broader temperature ranges result in less detailed images.

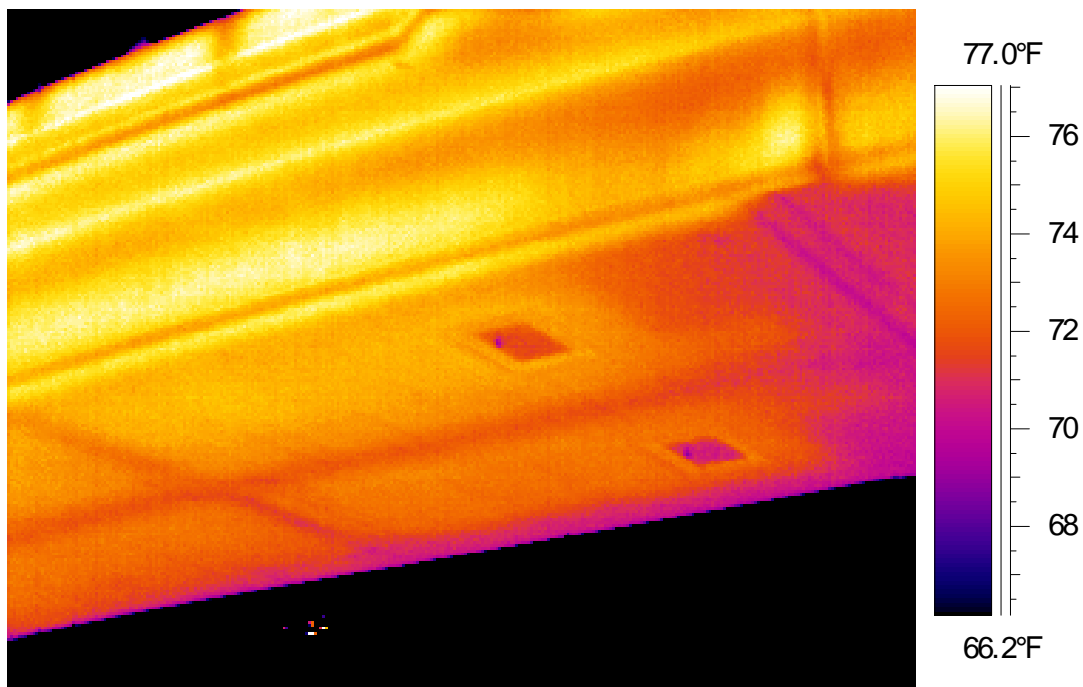
Figure 34 – Thermal image of Bridge 5/537E-N under ambient conditions

Before any inspections took place, thermal images of the bottom surface of the box girder under ambient conditions were analyzed to see if problem areas could be identified. Figure 34 shows a thermal image of the bridge under ambient conditions that encompasses most of Span 4. This thermal image displays the access hatches used during one inspection (Heating Location # 2). However, it does not reveal any specific problem areas. Without thermal identification to locate problem areas, visual analysis was used, in conjunction with access limitations, to determine heating locations. The positioning limits were based on access provided by WSDOT

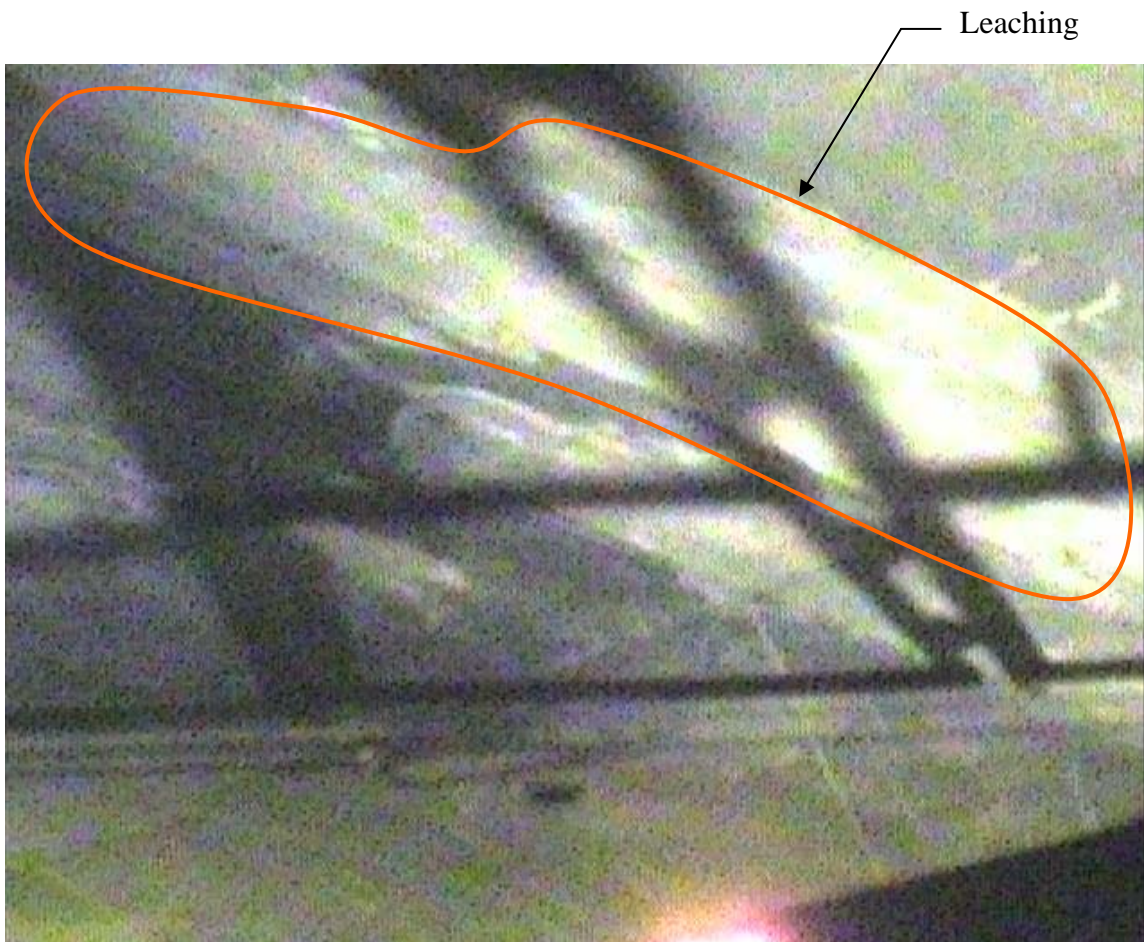
Heating Location # 1 was inspected on August 13th, 2007 using inspection Method 2. The inspection position was in Span 4, just west of Pier 3. The surface was heated for a time span of 0:40 (hh:mm). The top of the heater was placed approximately 107 cm (42 in.) below the heated surface. This region was chosen due to the extensive leaching on its surface, as displayed in Figure 35. The leaching shows up as the white area stretching across the photo and encircled by the orange line.

Figure 35 – Photo of Heating Location # 1 with extensive discoloration due to leaching

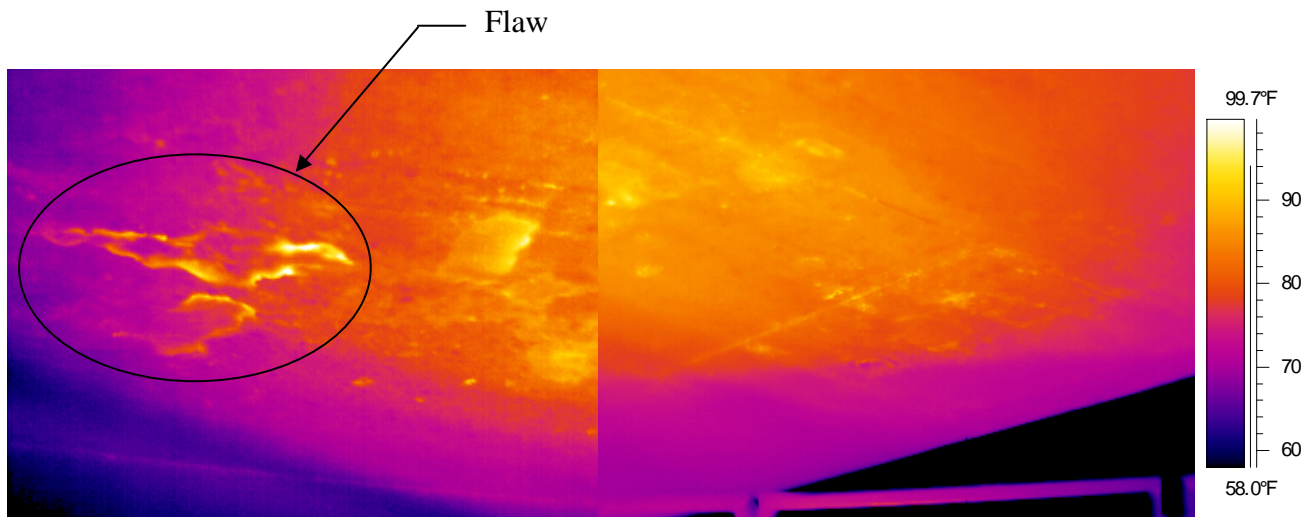
Figure 36 – Thermal images of Heating Location # 1, side by side

With this inspection, thermal images were taken throughout the heating process. The camera was placed on the lift platform approximately 3 m (10 ft.) to one side of the heater. Figure 36 shows two thermal images side by side that were taken approximately four minutes after heating began. The circled region demonstrates that after a fairly short heat time, surface characteristics and flaws were visible in thermal images. There were also other visible irregularities in the middle of the figure.

The thermal images in Figure 36 were taken in order to help locate areas that, with further heat input, might reveal subsurface flaws. The circled region shows what looks like a flaw, so the heater was moved so that its center was directly underneath this region, and then heating commenced again. From here, thermal images were taken every two minutes. Figure 37 shows a typical image progression during heating, or what one would see from the camera display. Figure 38 shows a single image from the progression.

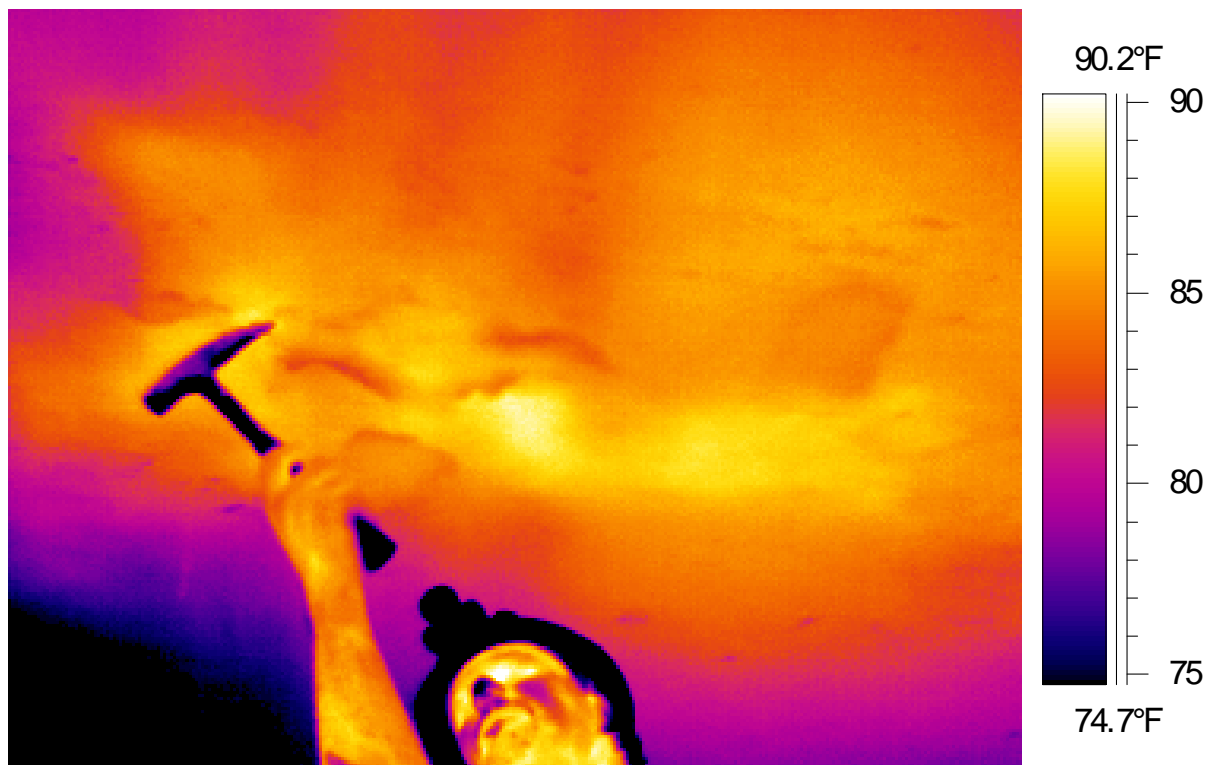
Heating Location # 1 was a very important inspection because, after heating was stopped, the surface was examined with a rock hammer. Tapping confirmed what was seen in the thermal images. A WSDOT inspector tapped part of the surface that had no apparent flaws (either visually or thermally) and then tapped at suspected flaw locations. Sound differences were easily discernable between the two locations, and then the pick end of the hammer was used to remove surface concrete and excavate the flaw. Delamination and poorly consolidated concrete (small air voids) were discovered. Figure 39 shows a thermal image of a WSDOT employee excavating the delaminated concrete at the flaw location shortly after thermal imaging inspection. This was the first inspection location where flaws discovered thermally were confirmed using physical means (tapping and excavation).

Figure 39 – Thermal image of Heating Location # 1: excavating a detected flaw

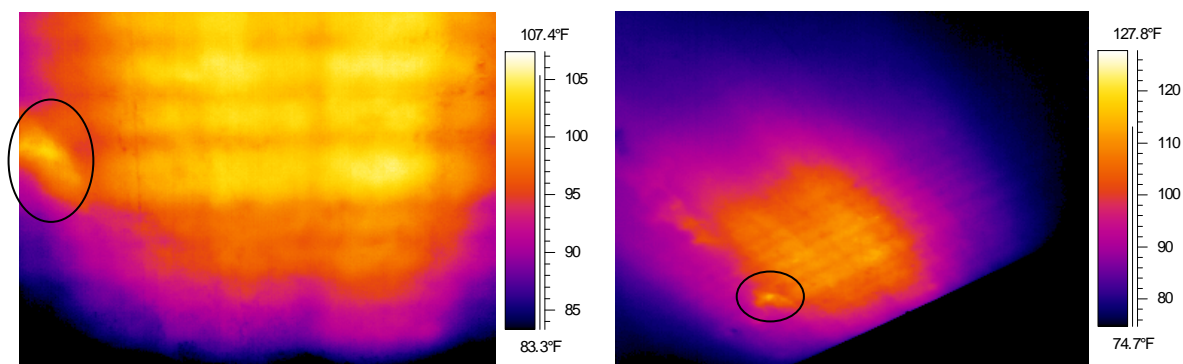
Figure 40 – Thermal images of Heating Location # 2

Thermal images from Heating Location # 2 do not reveal anything about the leaching or the unheated surface. Steel reinforcement inside the concrete is the only thing shown in the images. Figure 40 is comprised of two thermal images that show the reinforcing steel as cool lines between warmer regions. There is one hot spot, which is located inside the circled region in both thermal images.

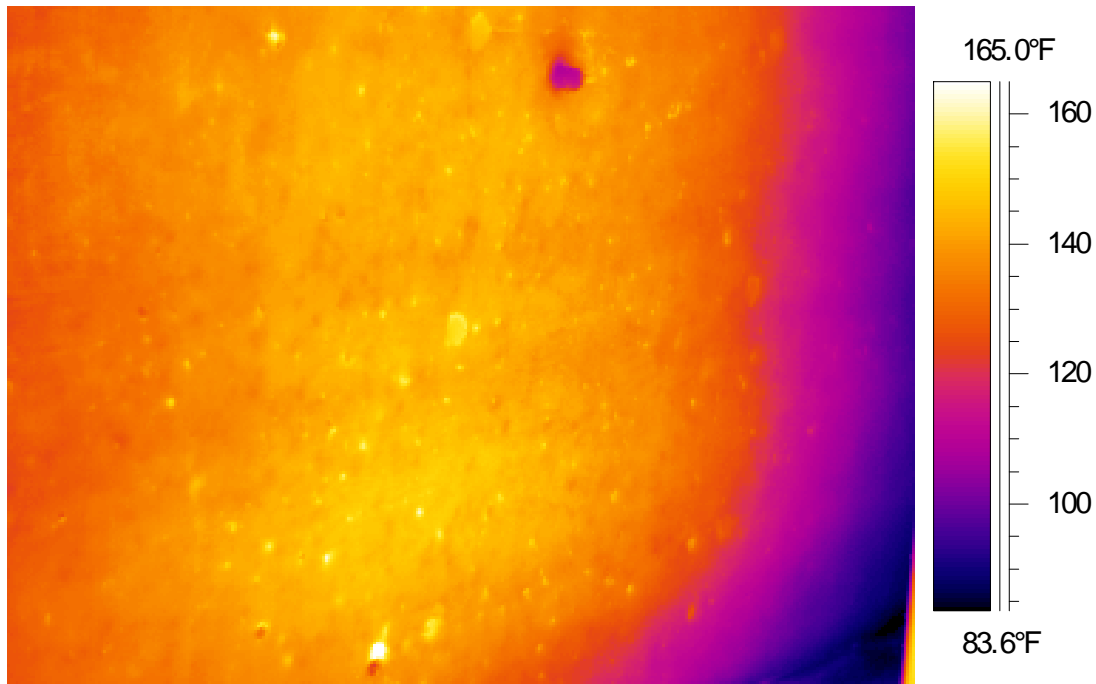
Figure 42 – Thermal image of Heating Location # 1 (30 minutes after heating began)

Figure 42 shows a thermal image of Heating Location # 1 taken approximately 30 minutes after heating commenced. This image illustrates the state of the concrete surface and its characteristics. A few hot and cool spots can be seen, but this image primarily reveals surface characteristics of the concrete.

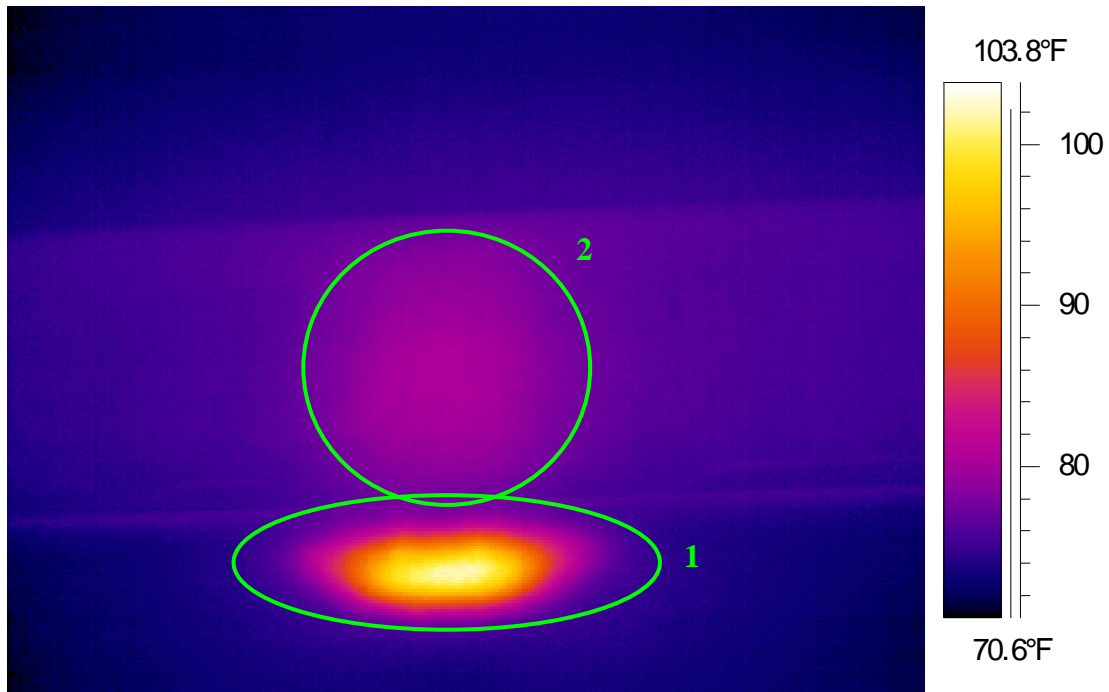
Figure 45 – Thermal image of Heating Location # 2 taken of the unheated surface

images taken of the unheated surface after five hours of heating did not reveal the PT-ducts in the box girder wall.
