Detection of Voids in Prestressed Concrete Bridges using Thermal Imaging and Ground-Penetrating Radar

WA-RD 717.1

December 2008

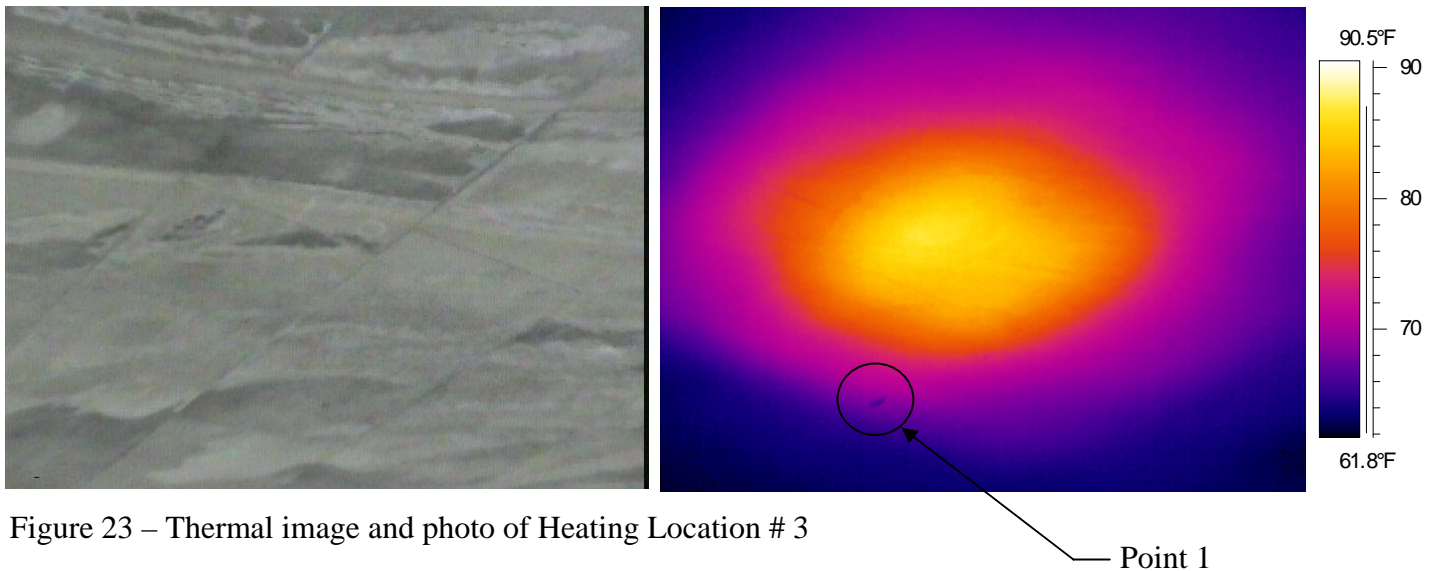
Heating Location # 3 did not reveal very many irregularities. A thermal image of this location is provided in Figure 23, and it only shows one small irregularity denoted by the circle. Using the thermal imaging software, temperatures at the irregularity and at a location just to the right of it were 66.3 °F and 68.5 °F, respectively. This is a 2.2 °F difference, which is not very big considering the temperature range of the image is approximately 28 °F. Due to the relatively

small temperature change and the lack of other irregularities around the point, it would probably not be classified as a point of significance. Heating Location # 3 would therefore be a good example of a surface with no apparent problems after inspection.

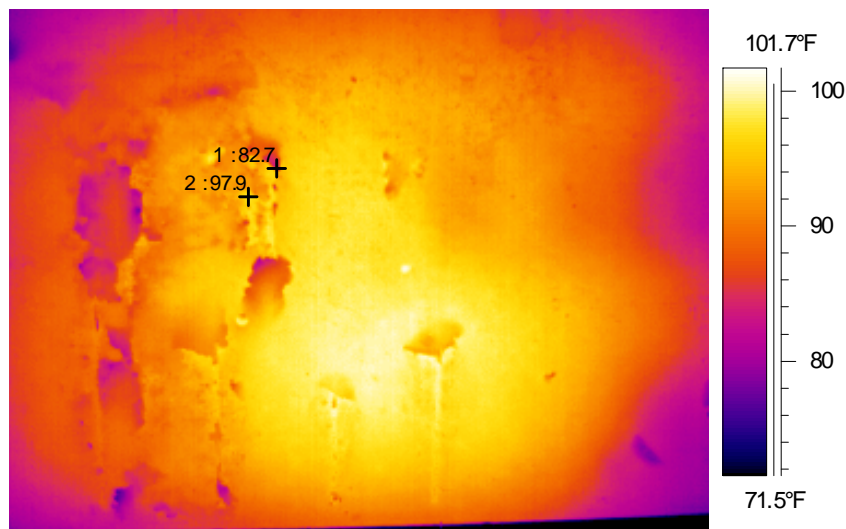
Figure 25 shows a thermal image of Heating Location # 5. This location was chosen because of the visible problems on its surface that were apparent from the ground. The thermal image in Figure 8 is packed with a lot of different types of irregularities, as shown by the great

differences in color (indicating different temperatures). Irregularities include spalled concrete, delamination, exposed steel reinforcement (rebar), and poorly consolidated concrete. Temperature differences in this image reach approximately 15 °F (like points 1 and 2 shown).

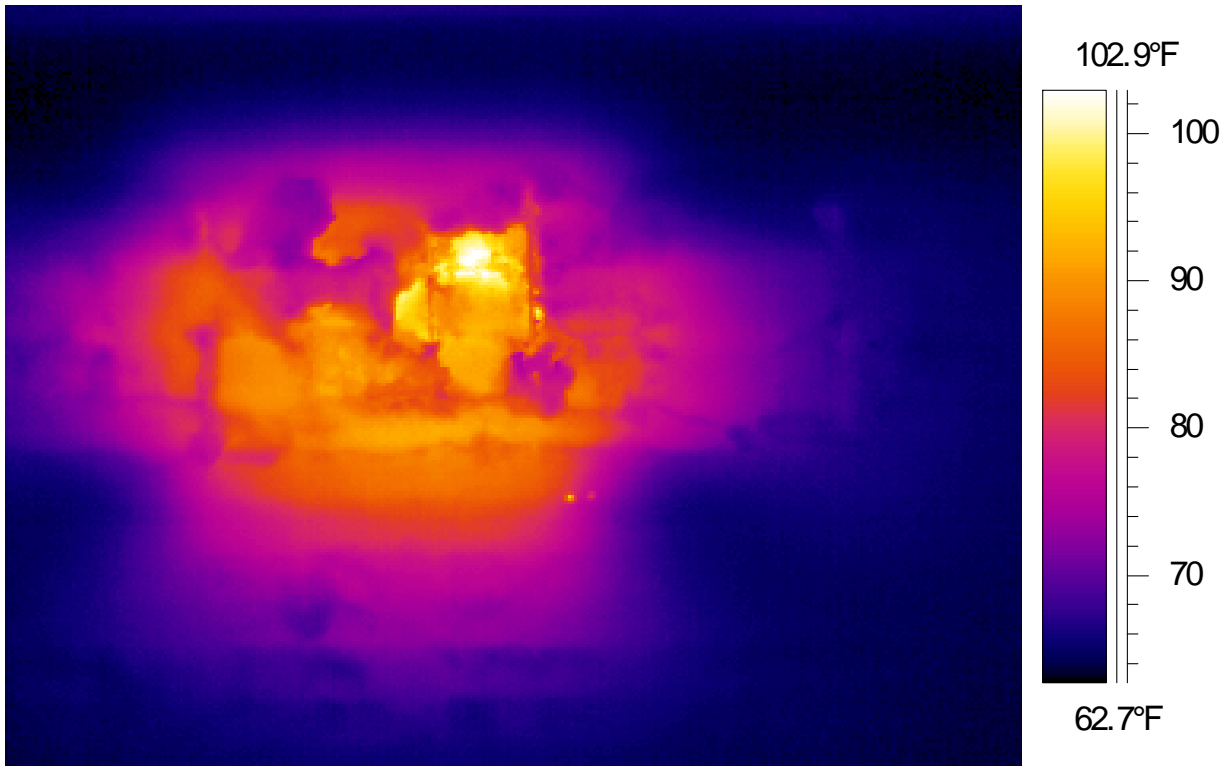
Figure 30 – Thermal image of Heating Location # 9

Figure 30 shows a thermal image of Heating Location # 9. There is great thermal variation in this image with temperature differences between 10°F and 25°F in the middle of the heated area. With Method 1 heating, irregularities like delamination appear as cool regions because the images were taken of the unheated surface. At delaminations, heat propagates at a slower rate than through a section of concrete with no irregularities, and thus a cool spot occurs on the unheated surface of a delaminated region.

The thermal image in Figure 30 was taken near the end of the heating process, at approximately 1:55 (hh:mm) after heating began. When heat propagates through a material as in Method 1, thermal images may still be obtained after the heat input has been removed. Even with no heat source, the heat already within the concrete will still propagate toward regions of lower temperature. During this inspection, thermal images were taken for two hours following the removal of the heat source.

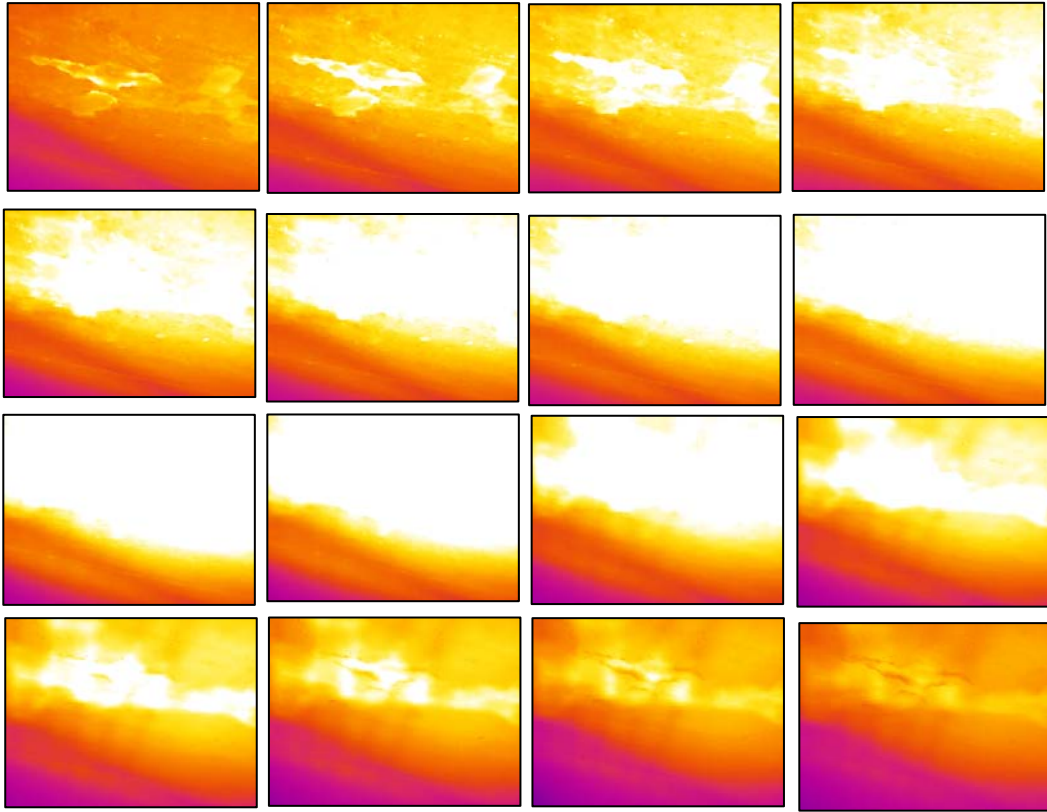
Figure 37 – Thermal image progression at Heating Location # 1

The thermal images in Figure 36 were taken in order to help locate areas that, with further heat input, might reveal subsurface flaws. The circled region shows what looks like a flaw, so the heater was moved so that its center was directly underneath this region, and then heating commenced again. From here, thermal images were taken every two minutes. Figure 37 shows a typical image progression during heating, or what one would see from the camera display. Figure 38 shows a single image from the progression.

Heating Location # 1 was a very important inspection because, after heating was stopped, the surface was examined with a rock hammer. Tapping confirmed what was seen in the thermal images. A WSDOT inspector tapped part of the surface that had no apparent flaws (either visually or thermally) and then tapped at suspected flaw locations. Sound differences were easily discernable between the two locations, and then the pick end of the hammer was used to remove surface concrete and excavate the flaw. Delamination and poorly consolidated concrete (small air voids) were discovered. Figure 39 shows a thermal image of a WSDOT employee excavating the delaminated concrete at the flaw location shortly after thermal imaging inspection. This was the first inspection location where flaws discovered thermally were confirmed using physical means (tapping and excavation).

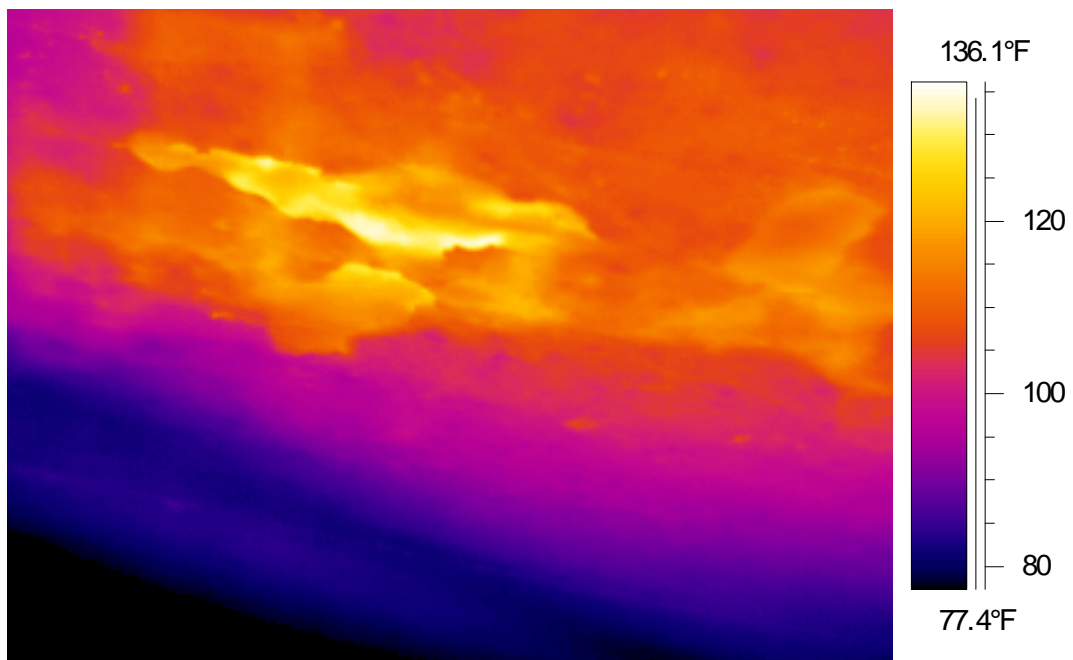
Figure 38 – Thermal image of Heating Location # 1 at middle of time interval

Field Inspection 2, conducted at an I-5 overpass (Bridge 5/537E-N) in Seattle, WA, was very successful because what was detected with thermal imaging was confirmed by “tapping” and excavation of the heated surface (at Heating Location # 1). The thermal images (Figures 36 and 38) suggested some sort of flaw (hypothesized as delamination), which was then verified by a WSDOT employee using a rock hammer to excavate the flaw. These inspections also confirmed that flaws can be visible in thermal images after only about 10 minutes of heat input (such as at Heating Location # 1).

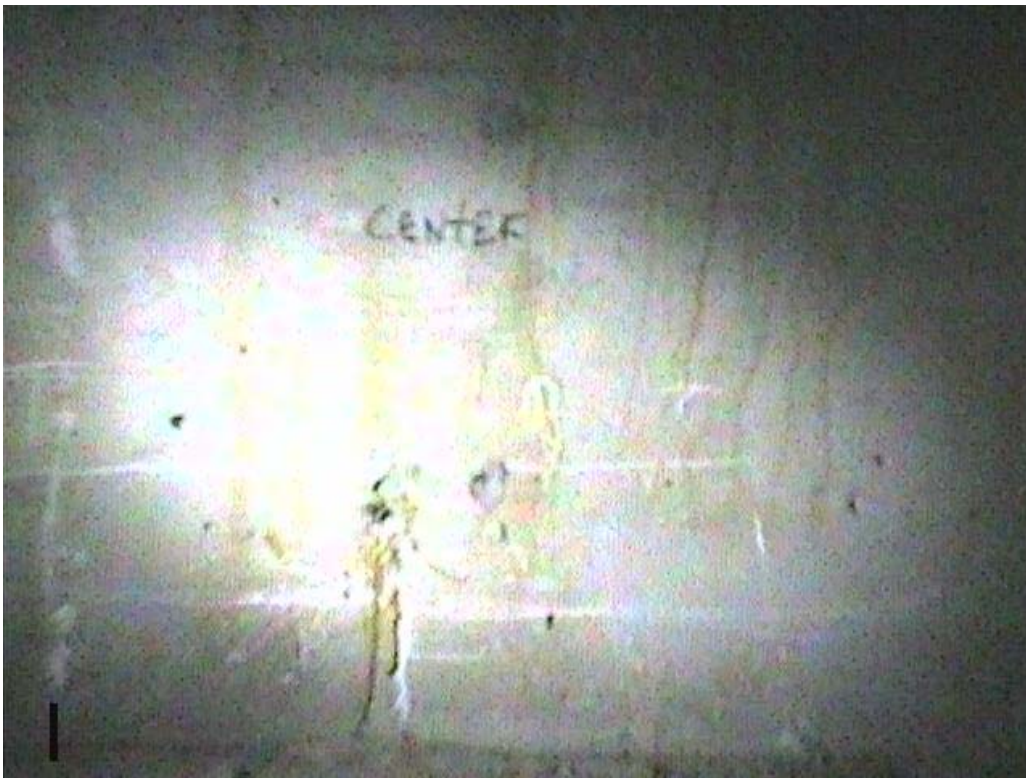
Figure 41 – Photo of Heating Location # 1

Heating Location # 1 was inspected on August 14th, 2007 using inspection Method 2. Figure 41 shows the inspection point of the interior web inside the box girder, which was located approximately at the midspan of the bridge, 12.2 m (40 ft.) from the edge of the access hatch. The surface was heated for a total time of 3:00 (hh:mm). This location entailed orienting the heater horizontally (so that the longer edge of the heater ran longitudinally along the box girder) on masonry blocks to raise the heater above the floor. The heater was approximately 61 cm (24 in.) from the heated surface and thermal images were obtained both during heating and for one hour afterward. During heating, the infrared camera was situated to the side of the heater and angled toward the heated surface.

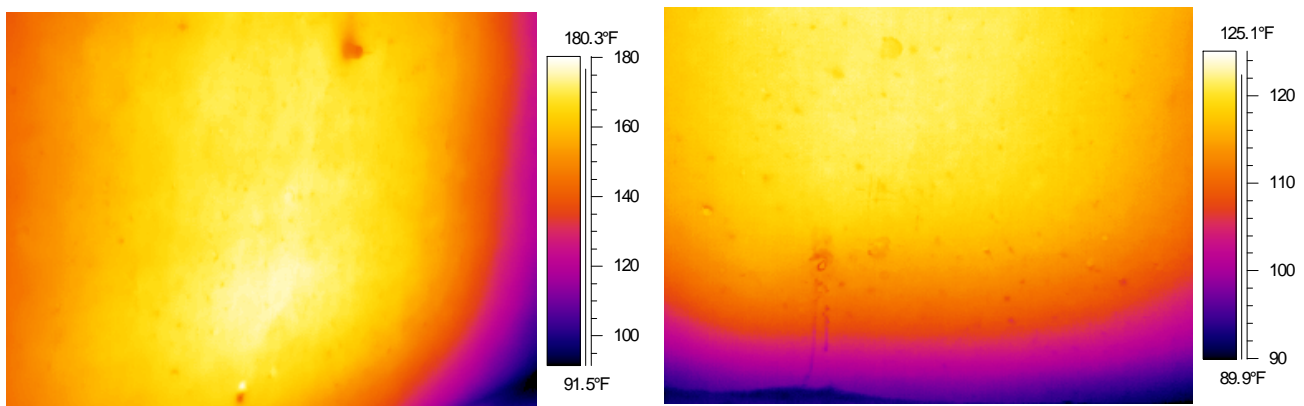
Figure 43 –Thermal images of Heating Location # 1:

The next two thermal images, shown in Figure 43, do not reveal anything regarding materials embedded in the concrete box girder web. The first image on the left was taken after 2:55 (hh:mm) of heating. The second image on the right was taken after the camera was moved directly in front of the heated surface, about 0:45 (hh:mm) after heating ended. None of the PT-ducts are visible in any of the thermal images, which indicates a couple of different things. First, three hours of heat input may not be enough to provide thermal images showing PT-ducts embedded in 30 cm (12 in.) thick concrete. Second, it is likely that the inspection setup was not

ideal for detecting the ducts. Inspection Method 2 involves taking thermal images from the same side as the heat input, and specimen inspections conducted in the lab indicated that Method 2 does not yield images showing inner-surface characteristics. Also, due to the confined area inside the box girder, the camera could not be placed as far from the heated surface as desired. Thus the camera lens could not capture the entire heated surface area. Unfortunately, since access to the opposite face of the box girder web was not available, Inspection Method 2 was the only option available.

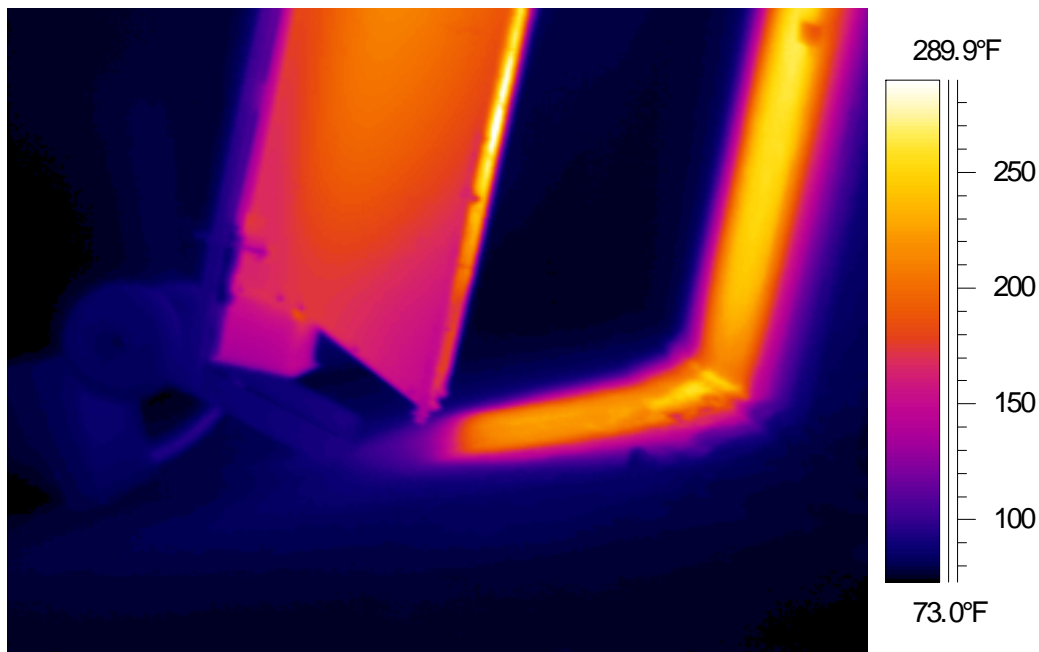
Figure 44 – Thermal image of Heating Location # 2 showing heater setup

The heater was not elevated, so both the box girder wall and floor were heated, as shown in Figure 44. Thermal images were obtained both during heating and for 40 minutes after heating ended.

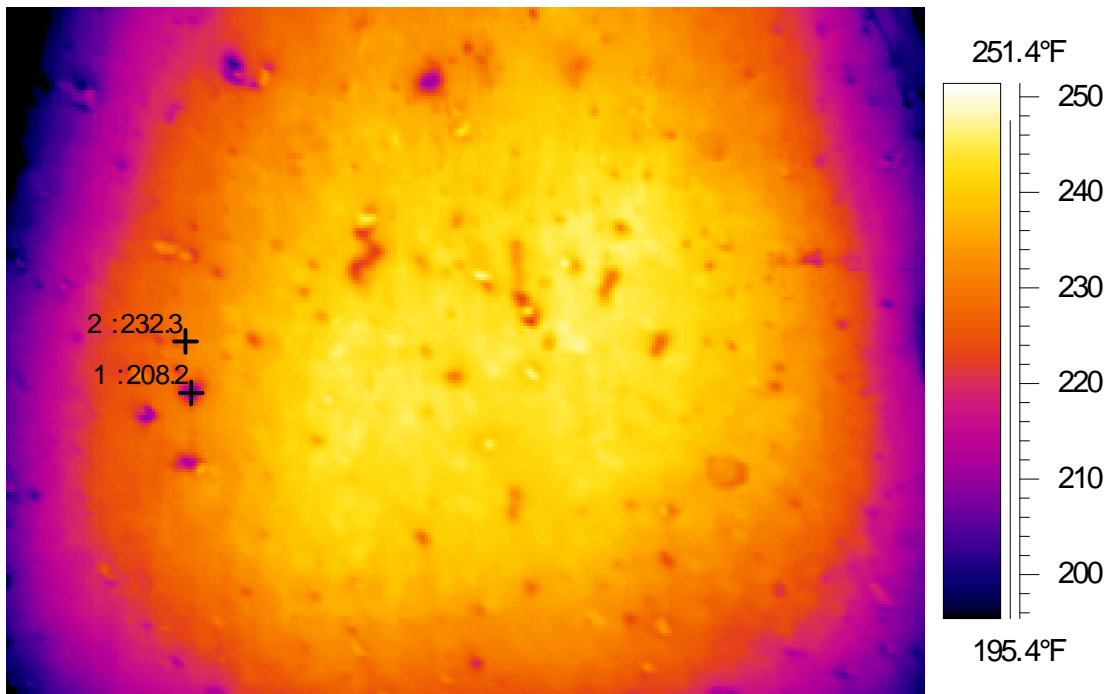
Figure 46 – Thermal image of Heating Location # 2 taken of the heated surface

Images of the heated surface were also obtained from inside the box girder after heating ended. Figure 46 displays one such image where surface characteristics are visible. However, as with Figures 44 and 45, the image does not show any PT-ducts. The flaws shown are mostly surface irregularities and small surface voids. Points 1 and 2 in Figure 46 show a temperature difference of approximately 24 °F in a span of only a few inches.
